FINAL REPORT
DEMONSTRATION OF 156 INCH MOTOR WITH
SEGMENTED FIBERGLASS CASE AND ABLATIVE NOZZLE

VOLUME II--STATIC TEST AND HYDROBURST (U)

December 1968

THIOKOL CHEMICAL CORPORATION
WASATCH DIVISION
Brigham City, Utah

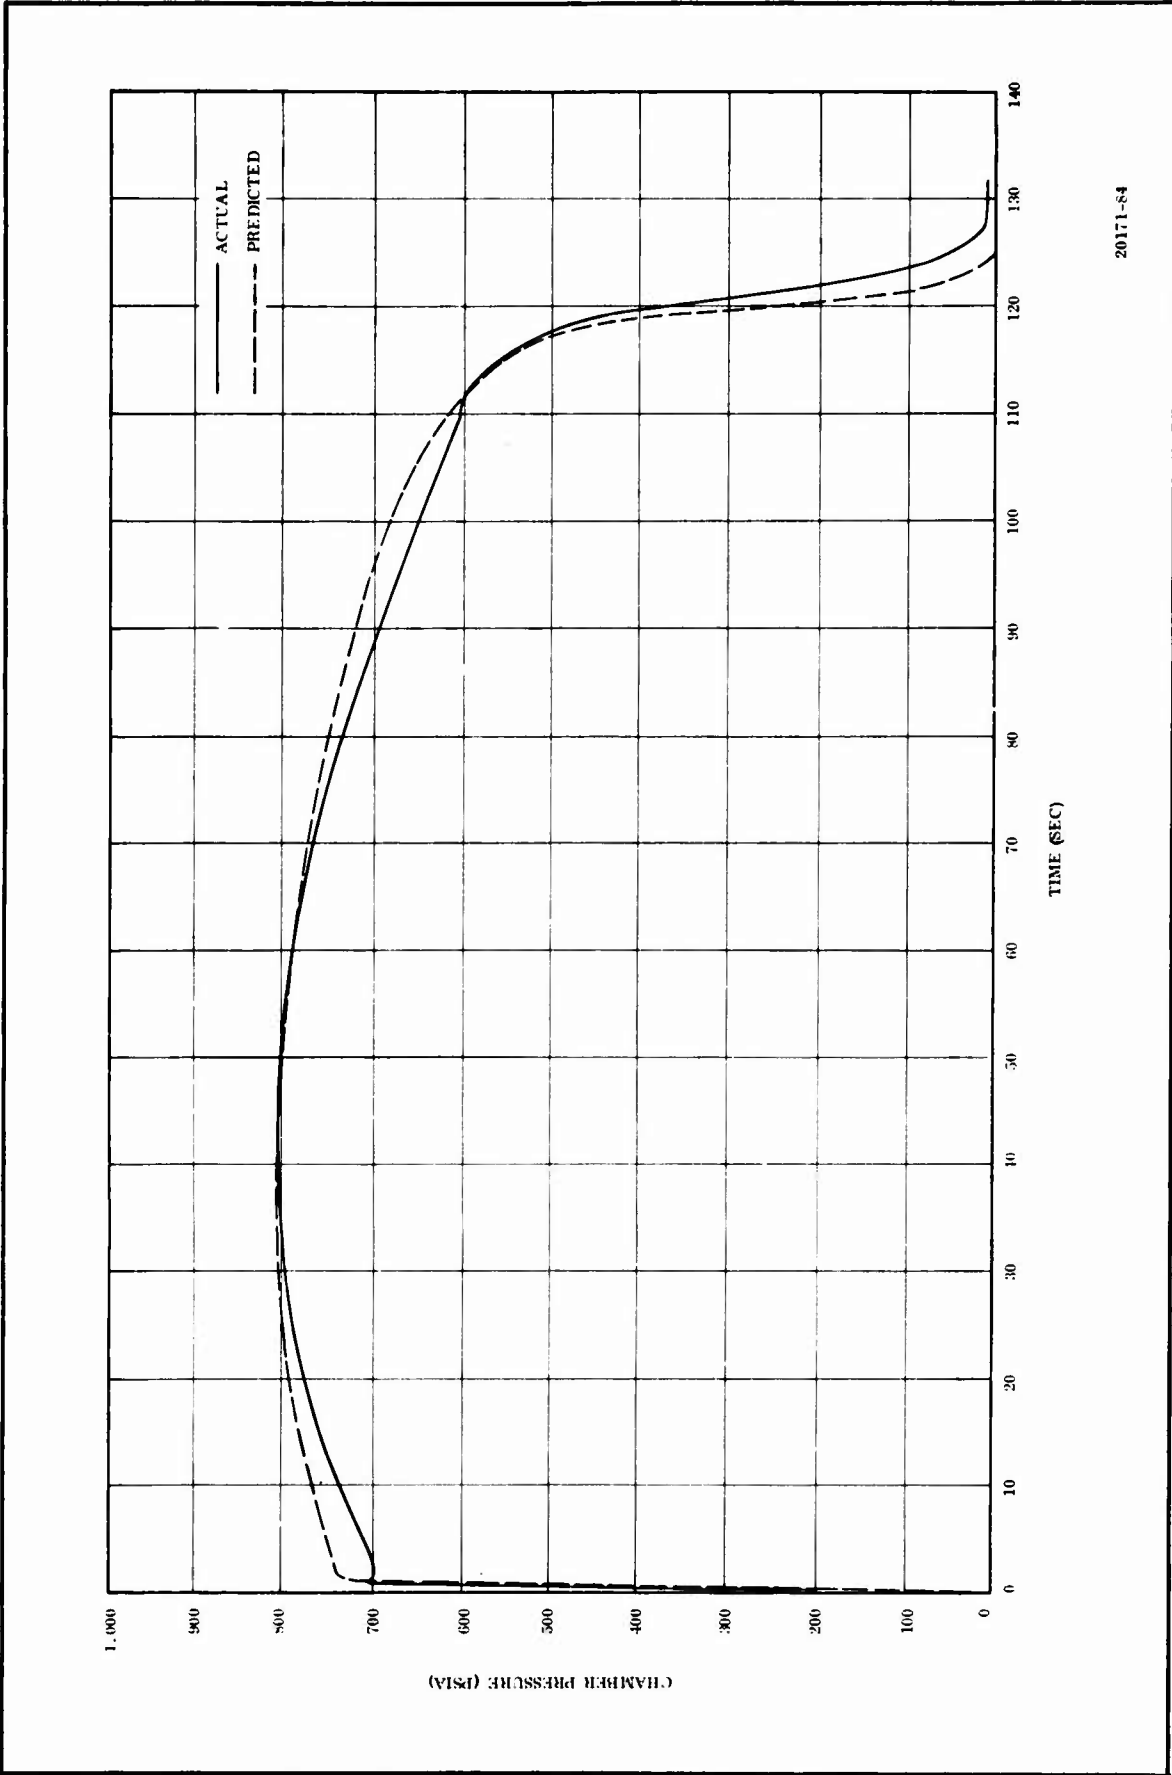
(C) Figure 6. Predicted and Actual Chamber Pressure, 70°F

- (U) The longer than predicted tailoff duration and the lower than predicted average pressure during tailoff resulted in an extended motor action time and a reduction in the overall average motor pressure during the action time interval. This performance apparently resulted from a more nonuniform propellant sliver than demonstrated by the 156-1C test. The slight difference in predicted and actual pressure and thrust decay rates can be directly attributed to deviations in the propellant sliver configuration.

- (U) Also contributing to the motor tailoff discrepancy was a marked pressure rise at 109 sec (Figure 6). This pressure buildup had the effect of delaying the beginning of motor pressure decay and essentially prolonging the tailoff time.

had burned approximately 36 in. into the propellant web. The region was known to contain propellant voids and folds. As the flame front reached the separated propellant portions, an increased amount of burning surface area was created, thus rapidly increasing motor chamber pressure. A hot spot occurred in the case wall in the cylindrical portion of the forward segment and was probably associated with the pressure rise.

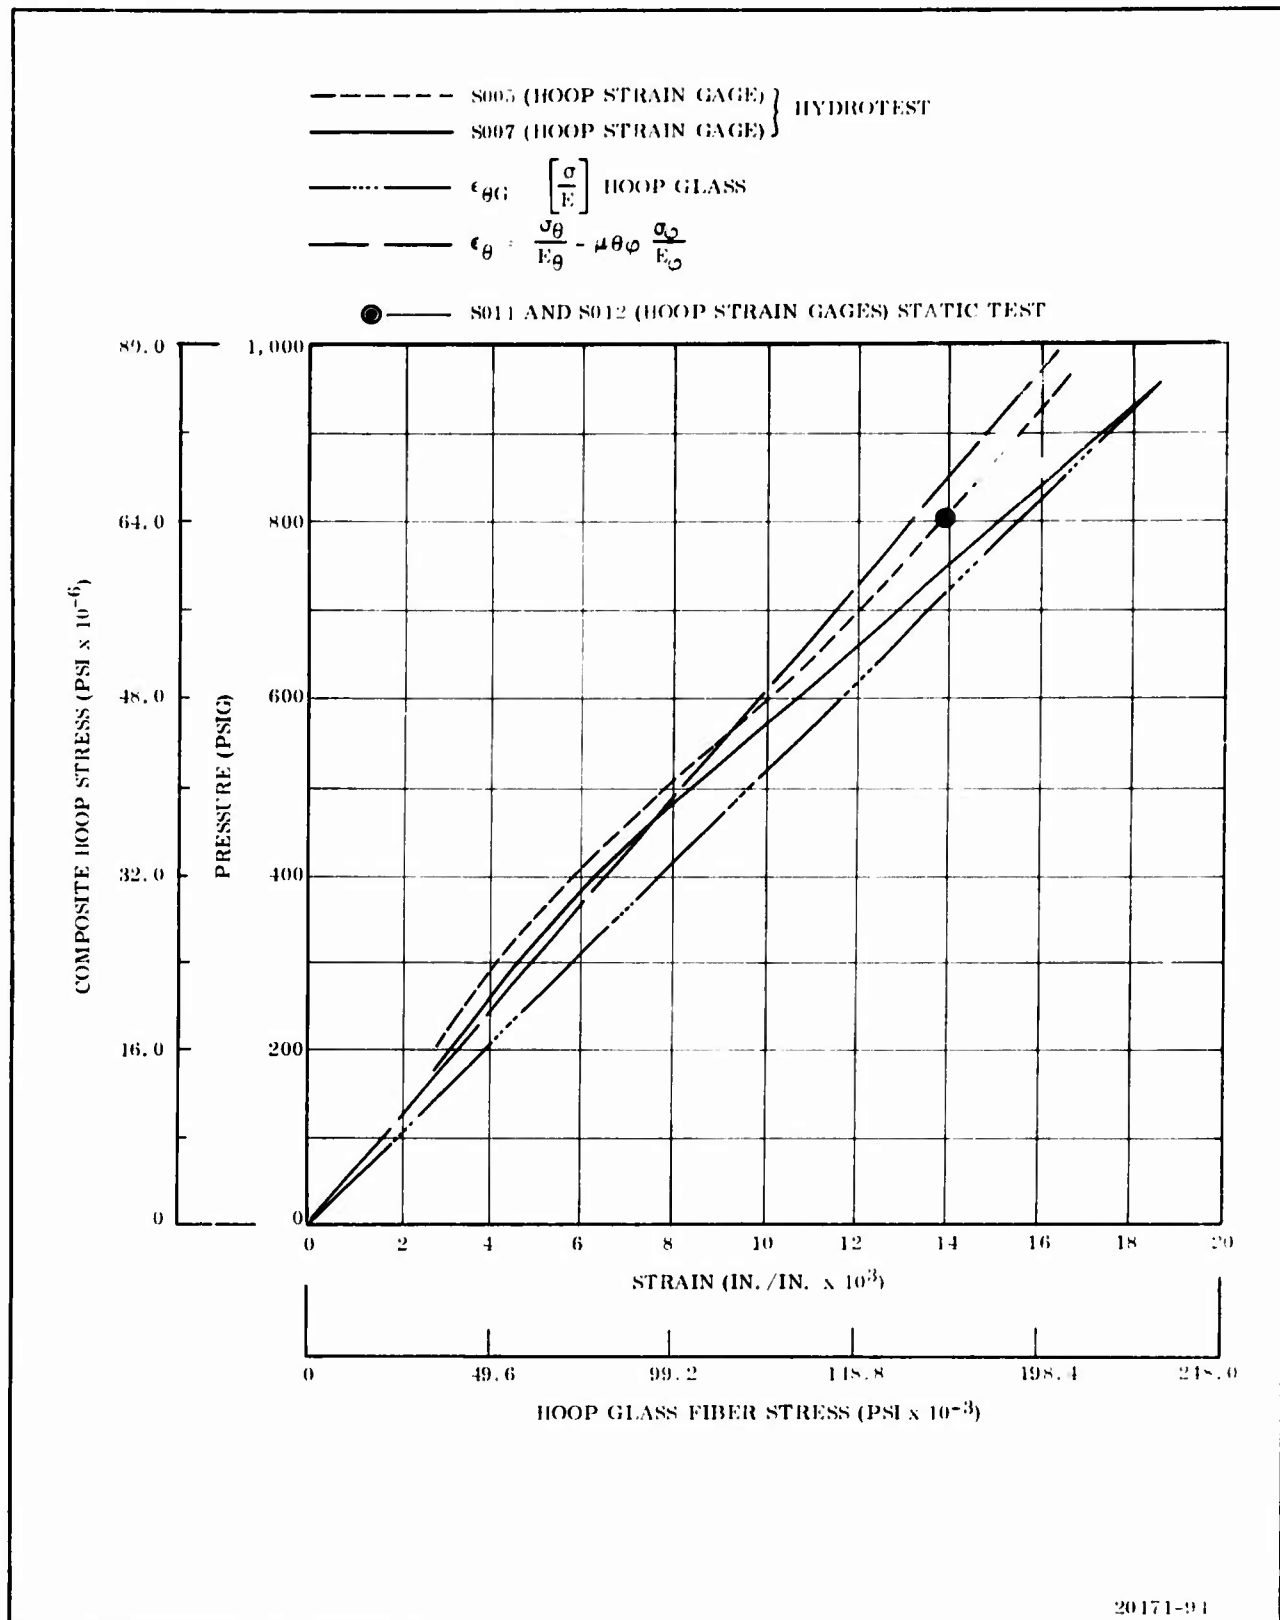
(C) Figure 12. Center Segment Hoop Strain

- (U) The reason for the difference in calculated and measured values of hoop strain is that the calculated value was based on the glass filament strain only while the measured value included the influence of the composite section of polar glass and resin. Strain gage data from the hydrotest of the case are compared with calculated data for filament and composite strains in Figure 12. The graph indicates that the measured values are between the two calculated values, but as the pressure increases the glass crazes and the behavior moves more toward the glass filament and away from the composite calculated value. The static firing results correlate closely with the hydrotest results as shown by the point plotted on the graph. Hydrotest data indicate the longitudinal strain behaves in a similar manner.

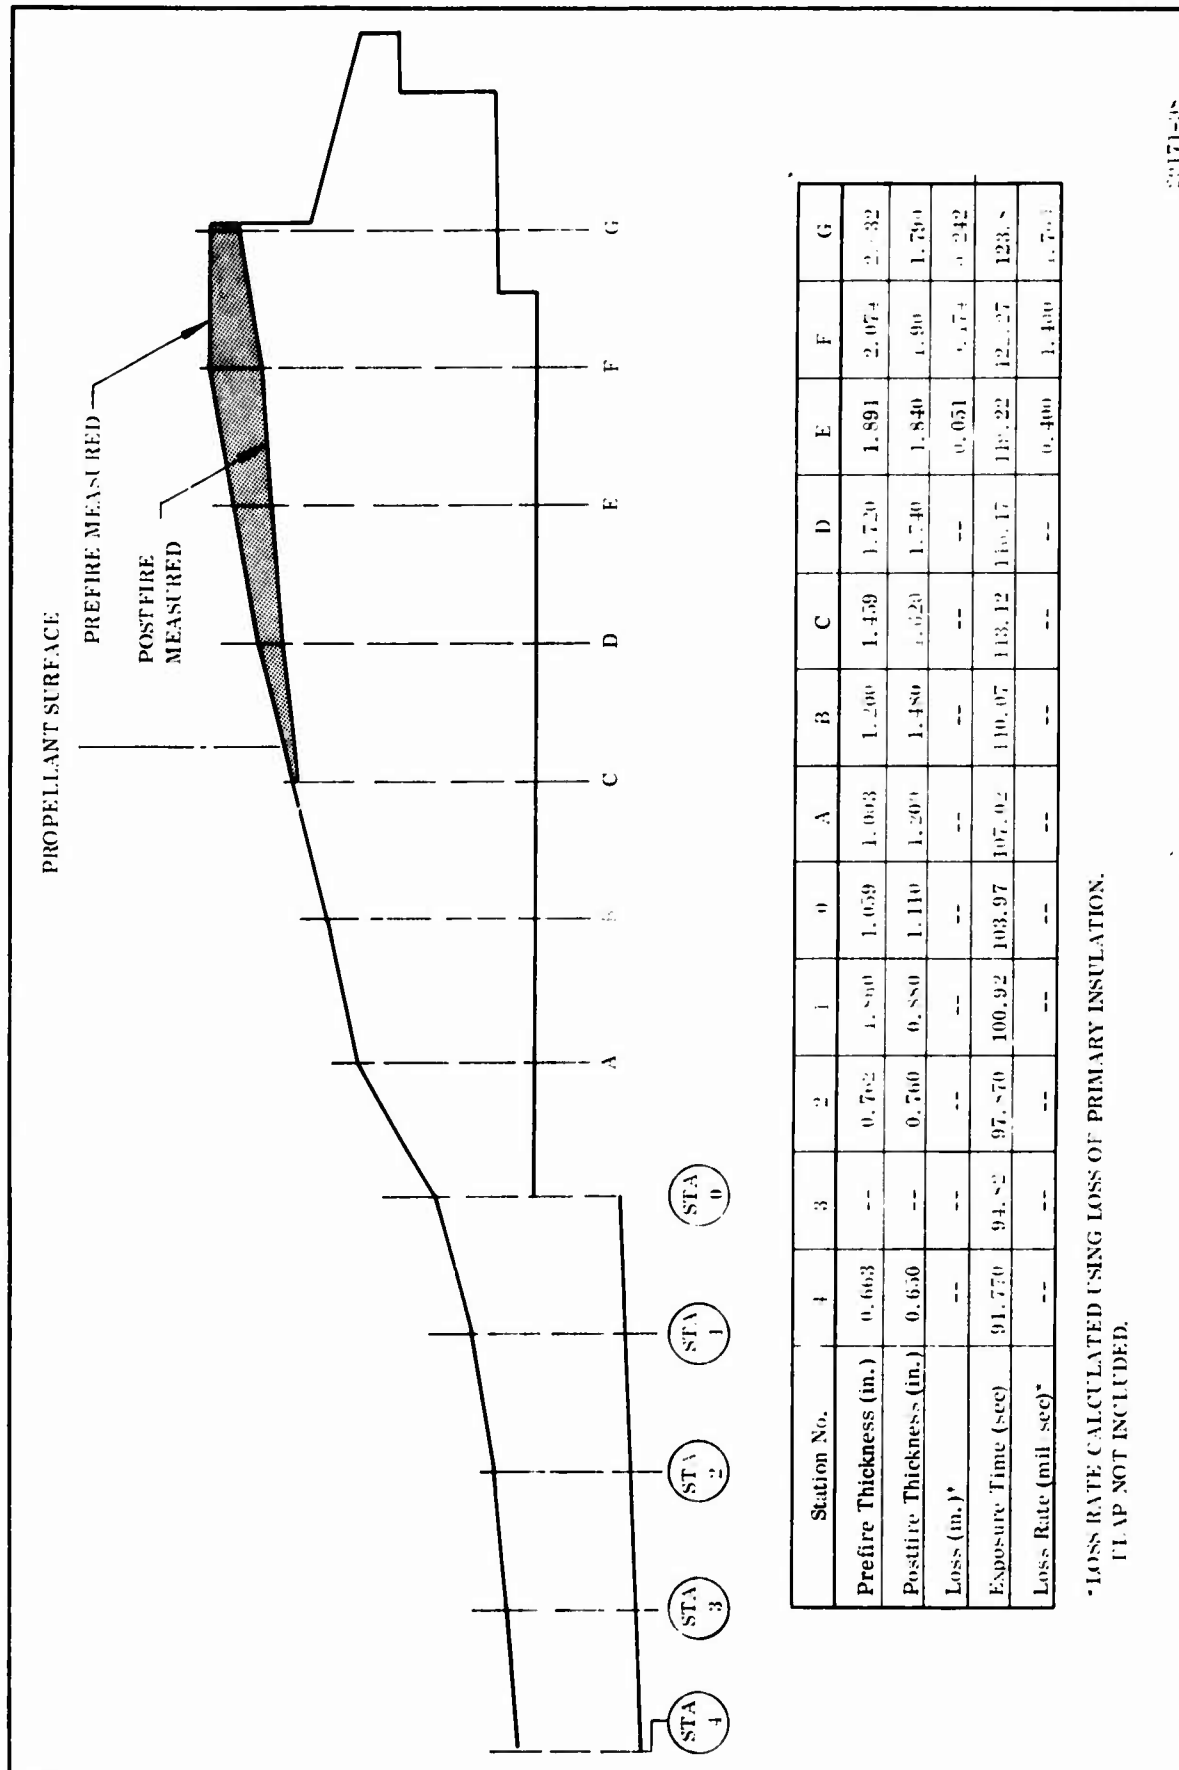
- (C) The joint insulation was measured to determine the insulation loss rate during the test. The maximum loss rate was 4.7 mils/sec in the forward joint. The average material loss rate in both joints was 1.7 mils/sec as compared to a predicted loss rate of 3.2 mils/second. Typical performance data for the joint area is shown in Figures 14 and 15.

(C) Figure 14. Insulation Performance, Aft Joint-Center Segment

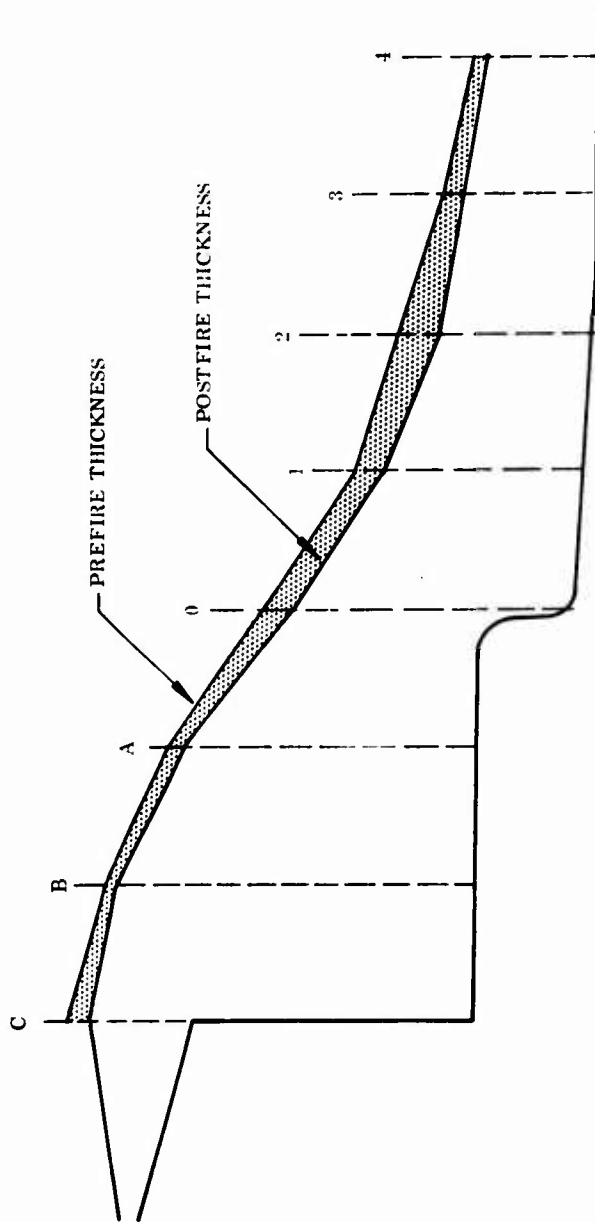
(C) Figure 15. Insulation Performance, Forward Joint-Aft Segment

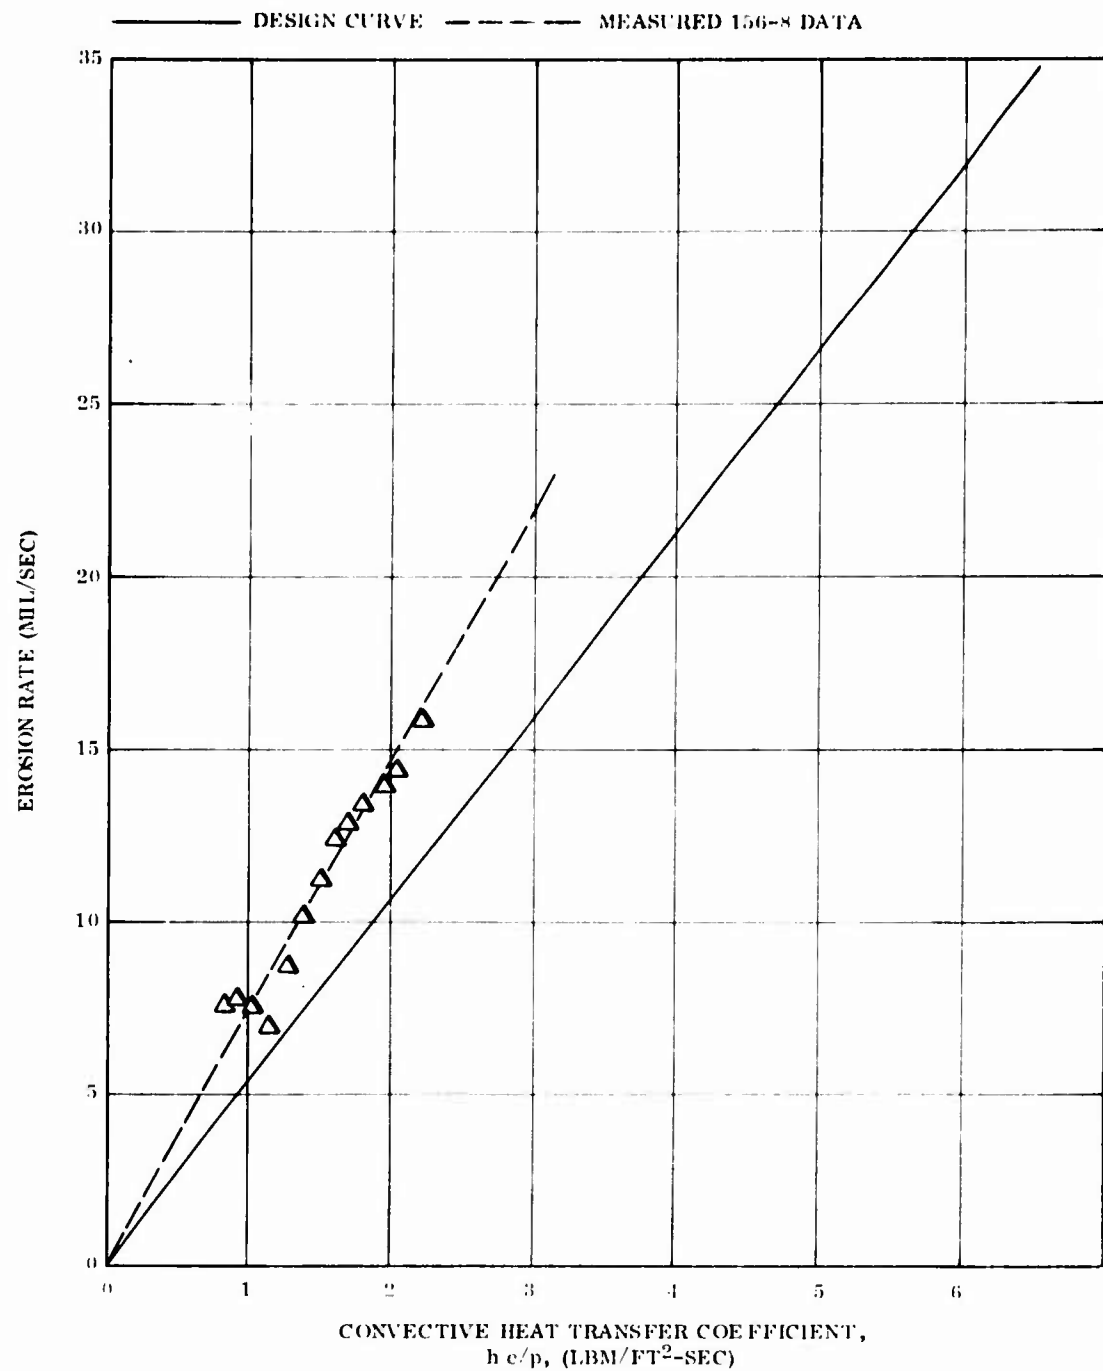
- (U) The erosion data obtained from the V-44 insulation material is correlated with the calculated convective heat transfer coefficient in Figure 18. The data show good correlation between heat transfer coefficient and erosion of asbestos filled NBR obtained from this test. The erosion rate in comparison to the convective heat transfer coefficient was actually higher than the relationship used for the design of the insulation.

(C) Figure 18. V-44 Insulation Erosion Rate and Convective Heat Transfer Coefficient

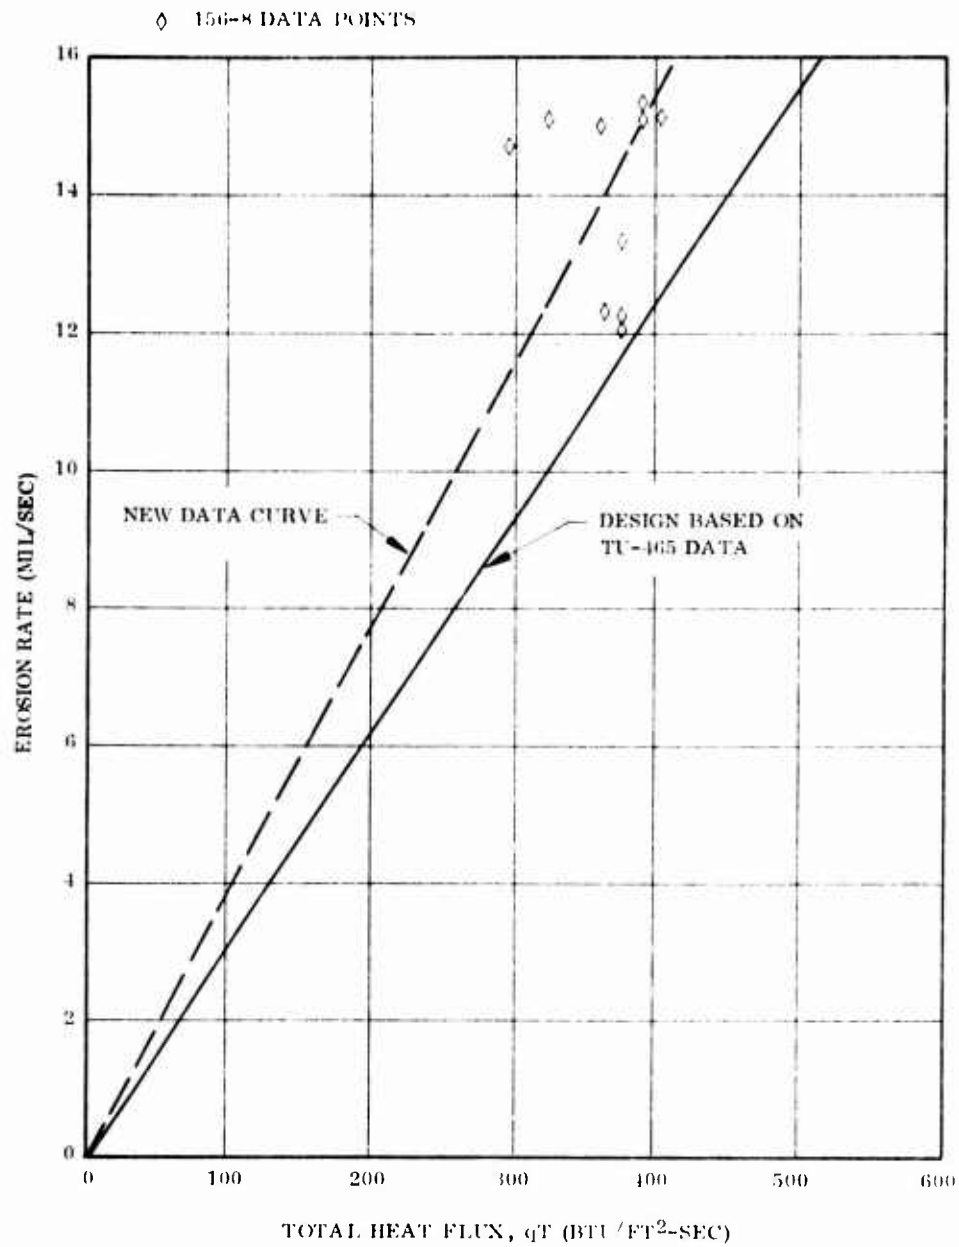
- (U) The silica cloth phenolic ring was designed from data obtained from the static test of the TU-465 motor. Using the erosion rate obtained from this test and total heat flux from the design analysis, a new curve was obtained (Figure 19). The new curve shows a higher erosion rate in relation to the total heat flux than used for the design of this motor.

(C) Figure 19. Erosion Analysis of Silica Cloth Phenolic Ring

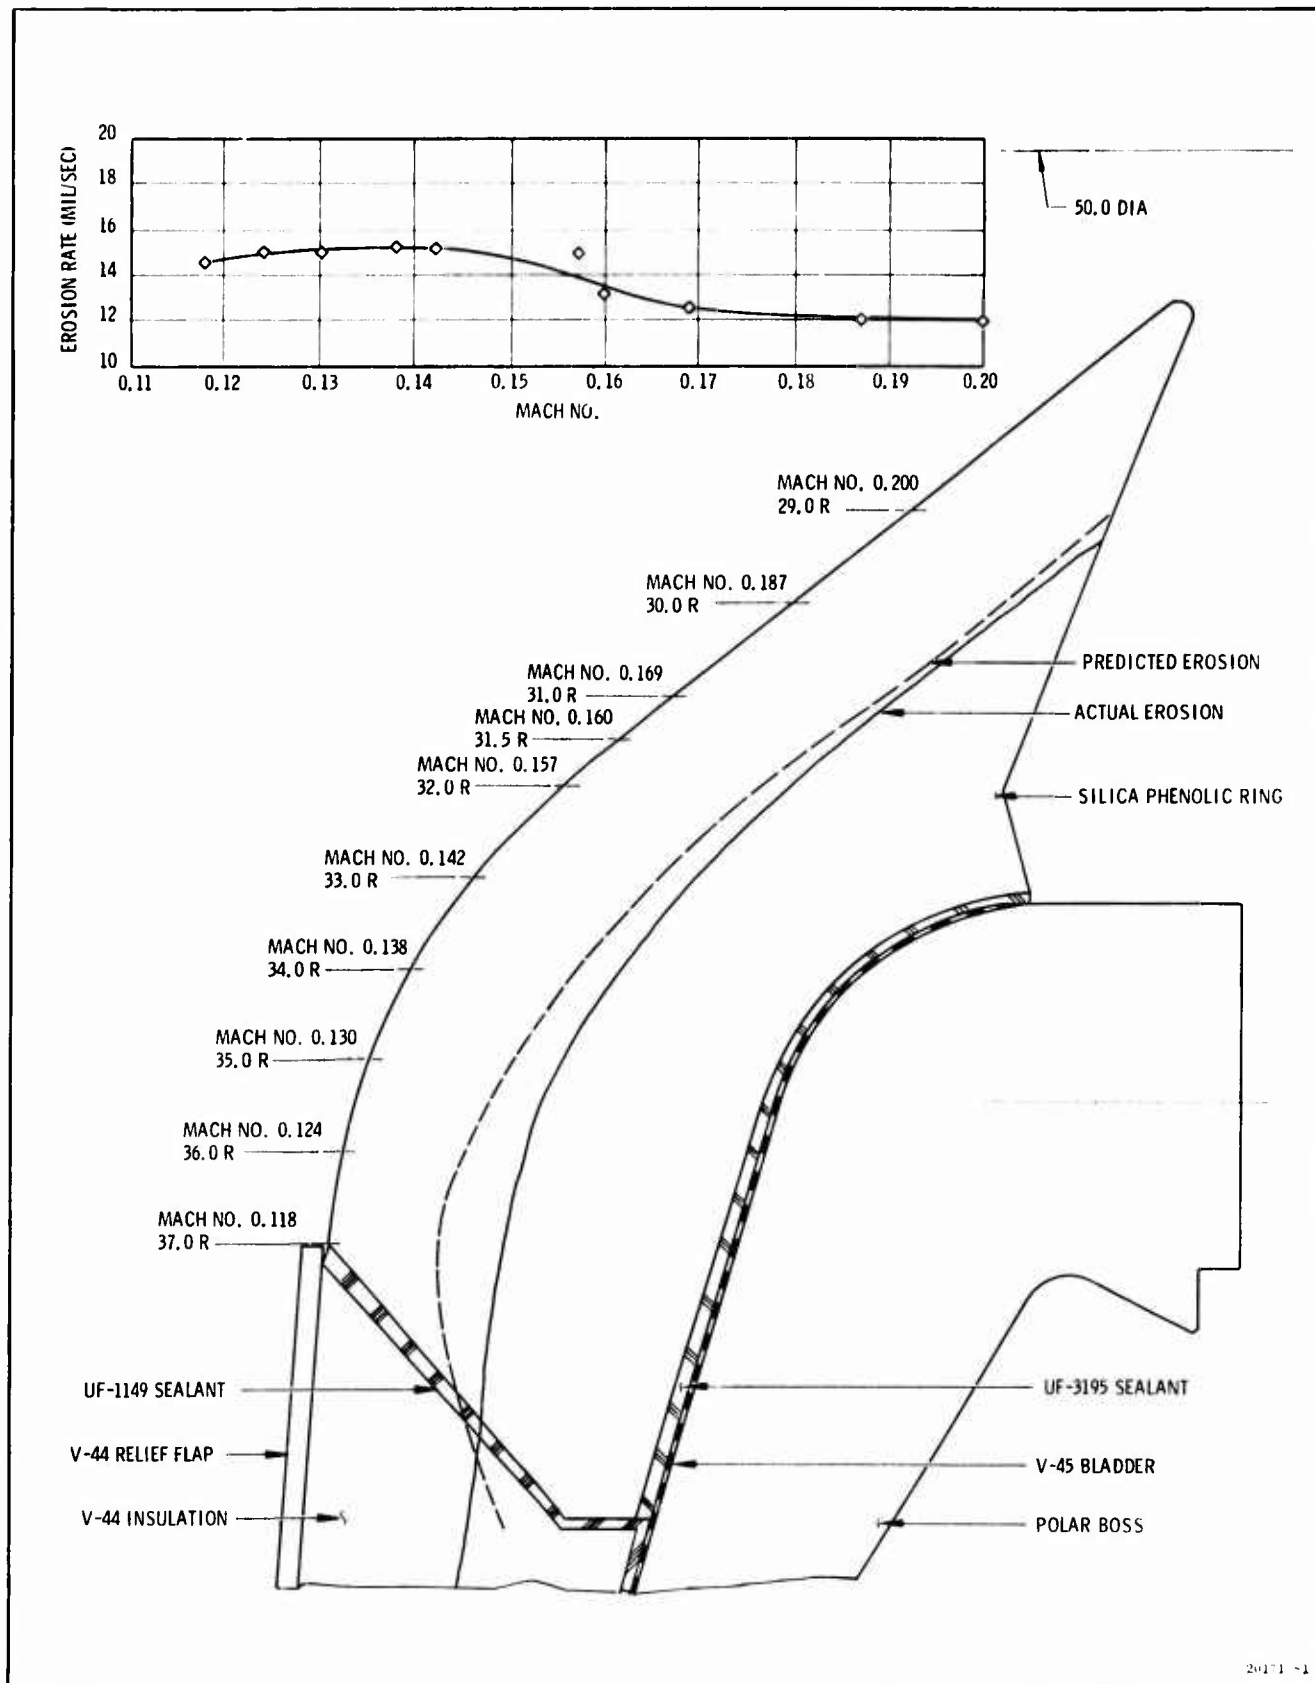
- (U) The gas velocity was also calculated for the area insulated by the silica cloth phenolic ring. The actual erosion vs predicted erosion and the actual erosion rate vs Mach number are shown in Figure 20. Due to the geometry of the part, there was a higher than predicted material loss rate between the 37.0 in. radius and the 32.0 in. radius. The relationship between the erosion of asbestos filled NBR and silica phenolic is shown in Figure 21.

(C) Figure 20. Aft Dome Erosion Data

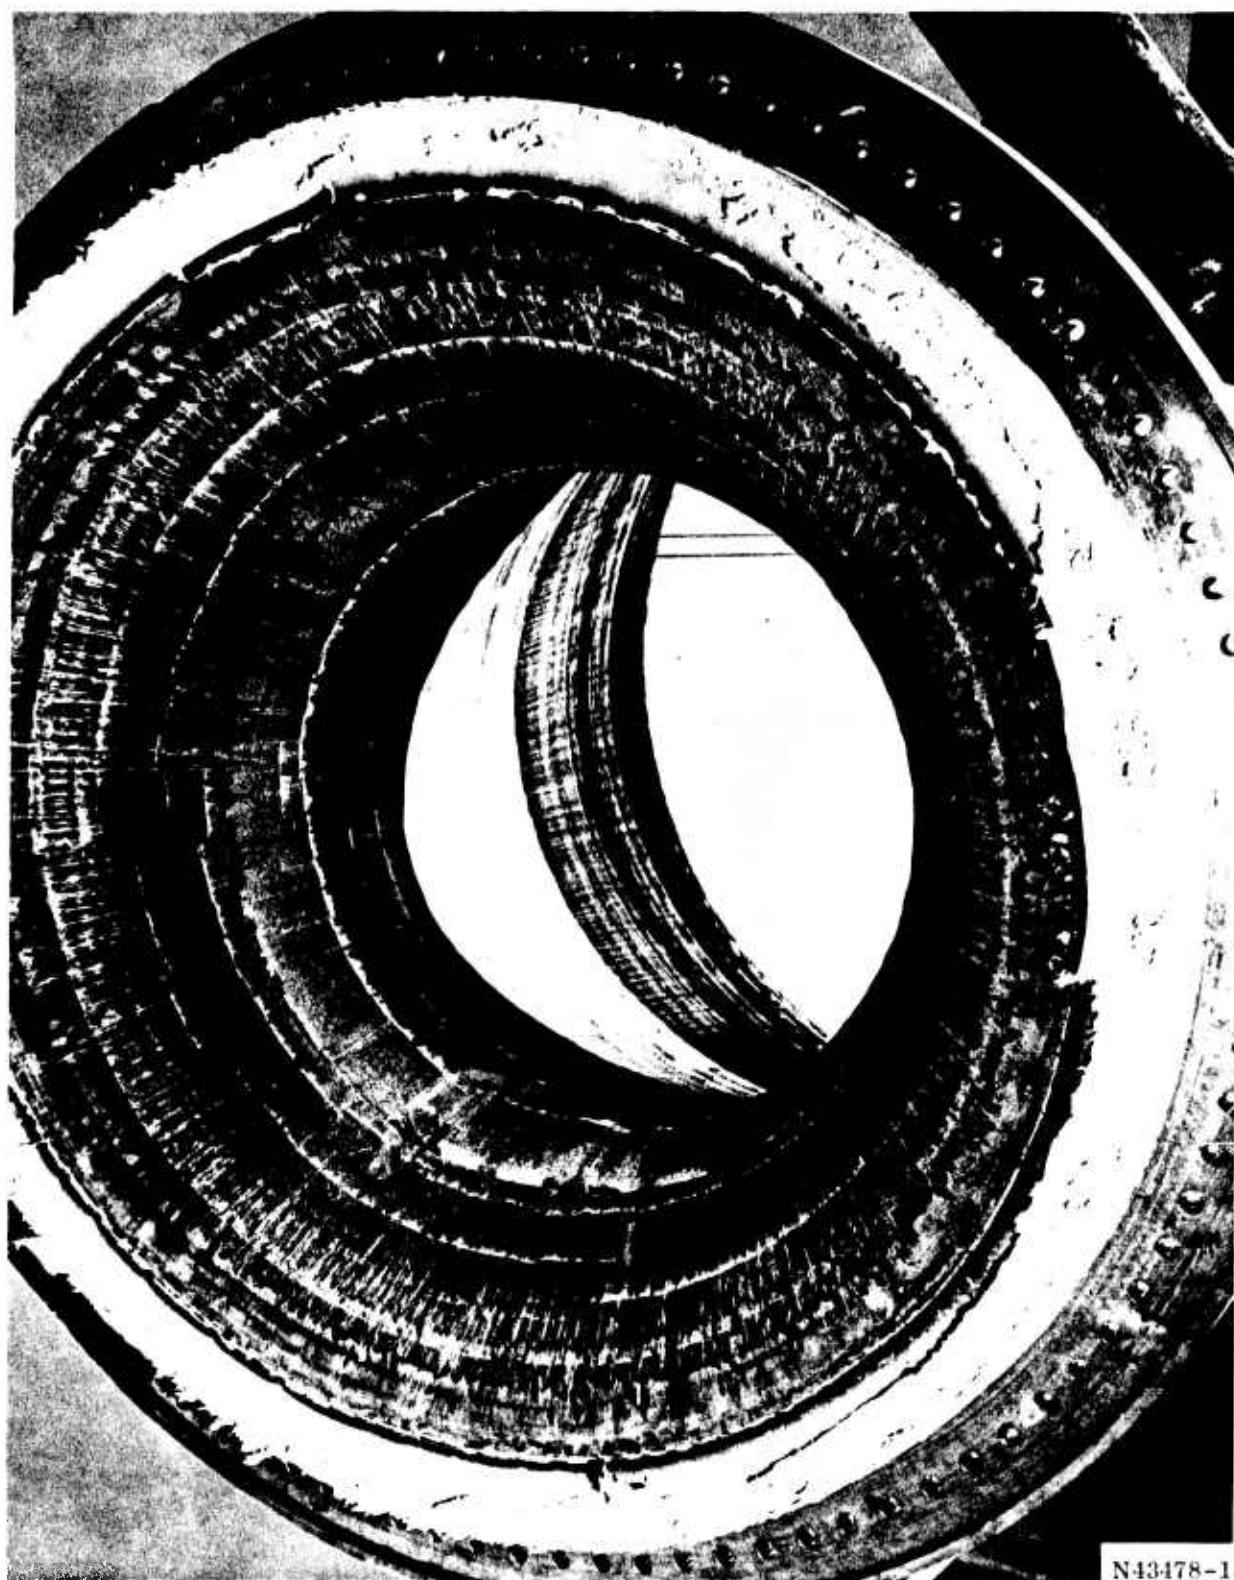
(U) Figure 27. Closeup of Nozzle, Internal View

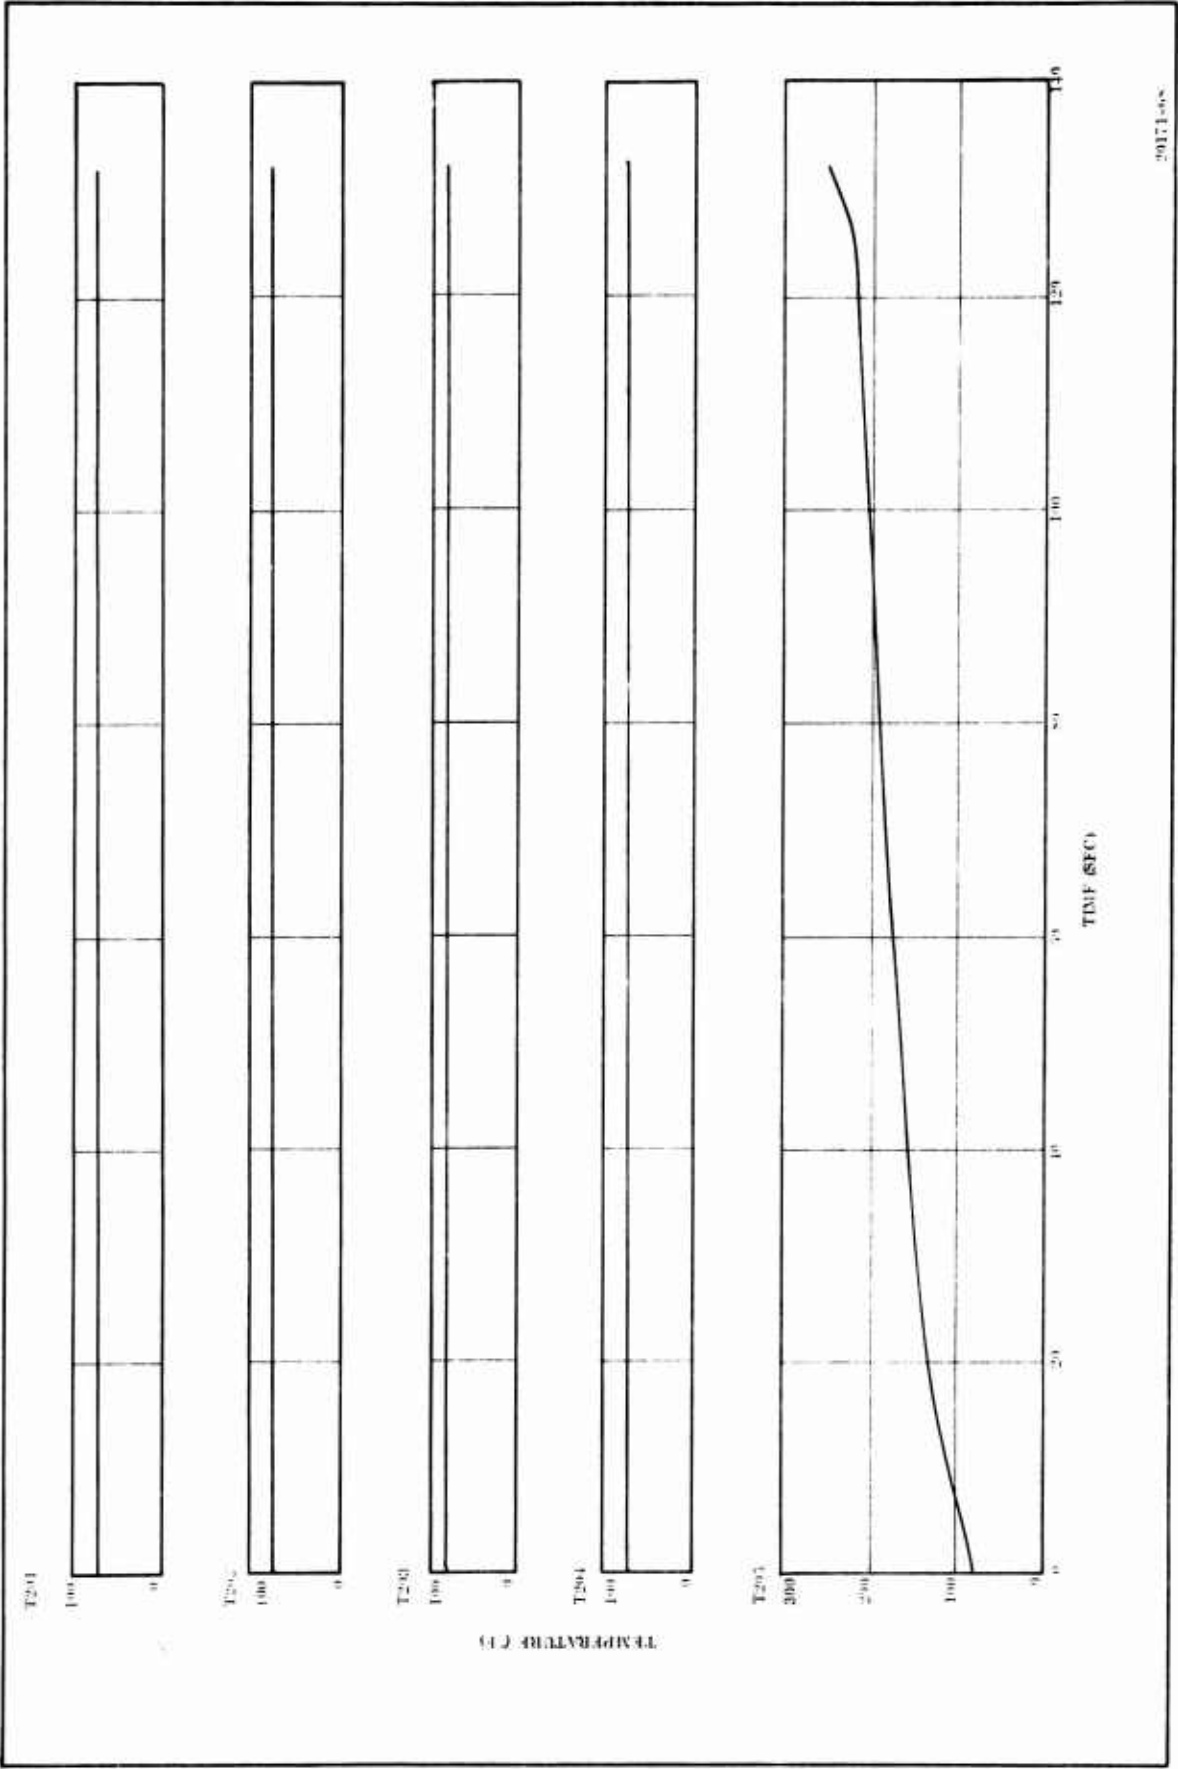
(C) T201 thru T204 all remained at 75° F, ambient temperature, throughout the test. T205 (Figure 36) rose from ambient shortly after ignition to 215° F at the end of burning time. This rise in temperature was due to radiant reflection of heat from the test bay floor as T205 was located at 0 deg circumferentially. The sudden

(C) Figure 36. Temperature Plots (T201 thru T205)

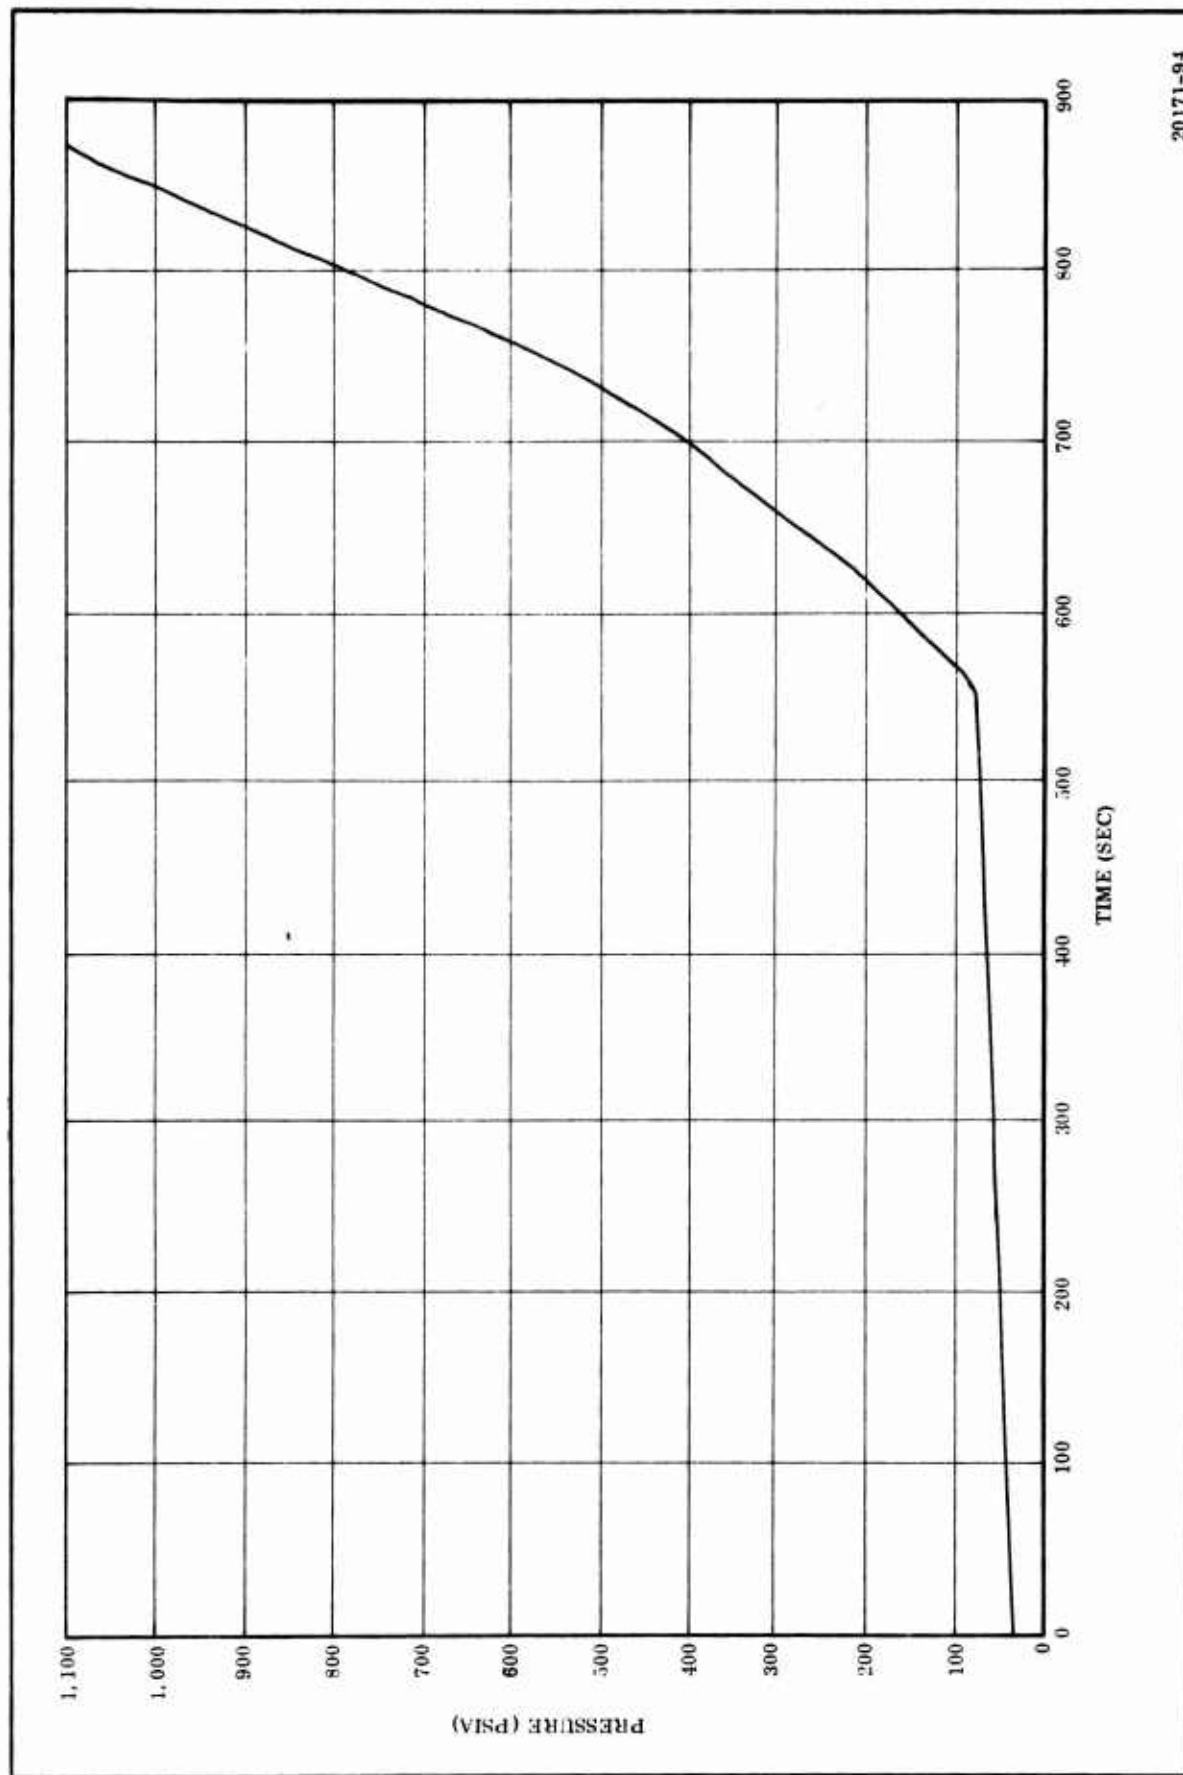
(U) Figure 51. Hydroburst Pressure Chart

The Halliburton high pressure pumps and piping system were connected to the case pressurizing system. After reaching a manifold pressure of 75 psig, the nominal pressure rise rate was held at 2.5 psig/sec up to 500 psig and at 4.3 psig/sec from 500 psig up to burst. The case failed at 1,095 psig (Figure 51). The pressure recording device was at the aft end of the case. The pressure at the case failure location was actually 1,110 psig due to hydrostatic waterhead.

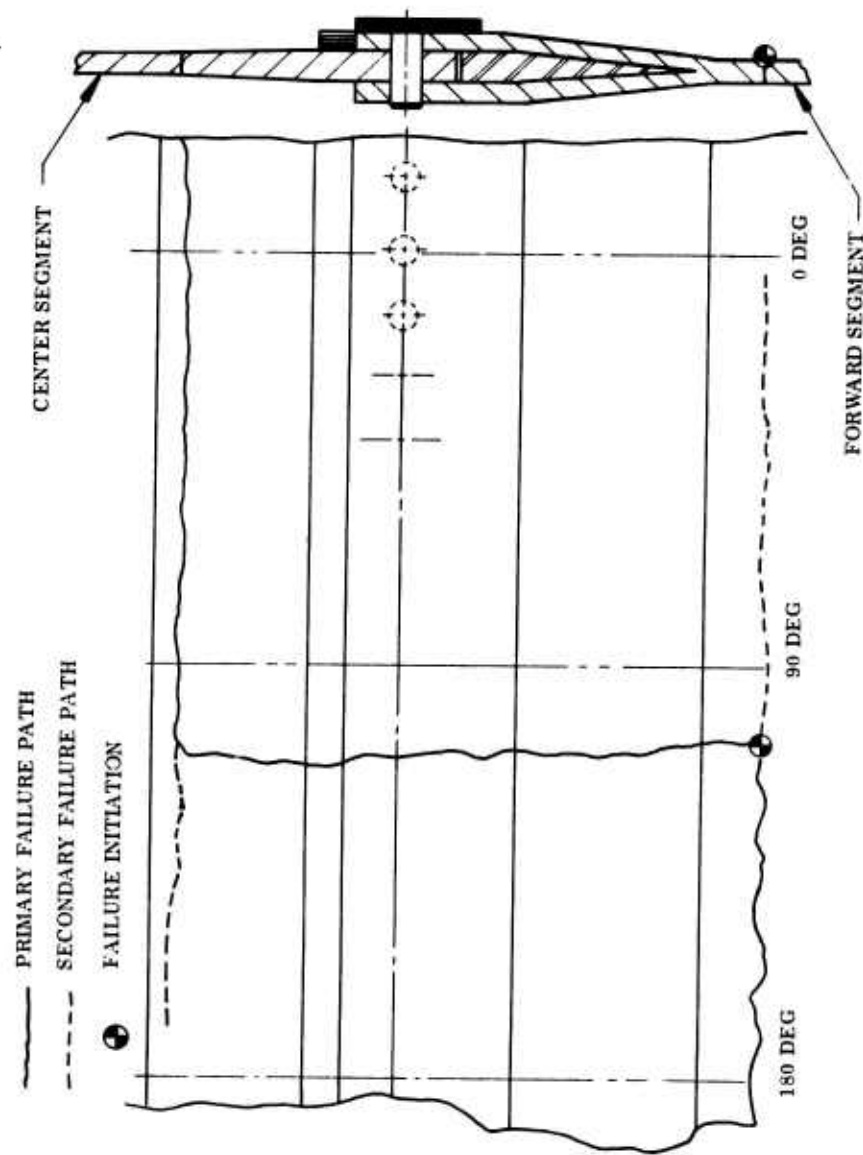
(U) Figure 52. Case Crack Propagation at Burst

The forward skirt buckled first at the 90 deg location and rotated counter-clockwise (viewed from the front of the test stand). The forward dome was severely buckled.

FLAT CASE PATTERN WITH 0 DEG AT
FRONT OF TEST STAND

(U) Several factors caused the failure to occur in the forward segment. Inspection of sections taken from the forward segment in the failure area showed a very dry laminate. Because of the dry condition, several layers of glass were removed prior to the third hydrotest for bladder replacement. The most important factor was the insulation burning through during static test (see Figure 22). Several layers of glass were burned through and the effect of the heat soak on the remaining composite could not be determined. The calculated hoop and longitudinal stresses in the forward and center segments were as follows:

(U) The calculations reflect the number of layers damaged, burned or removed, but they do not reflect the effect of the heat affected layers. The heat generated from the burnthrough in the static test in combination with the dry laminate caused a hoop failure at a glass stress of 294 ksi.

(U) Once the crack had propagated through the hoop ring on the inside of the joint, the added case bending caused by joint bulging created longitudinal crack propagation. The inner clevis leg failed first allowing water to flow between the clevis leg and the microballoon epoxy filler and out through the joint. The films show water bursting from the joint at the front of the case (0 deg location). The films also show that the complete longitudinal failure occurred in less than 1/200 second.

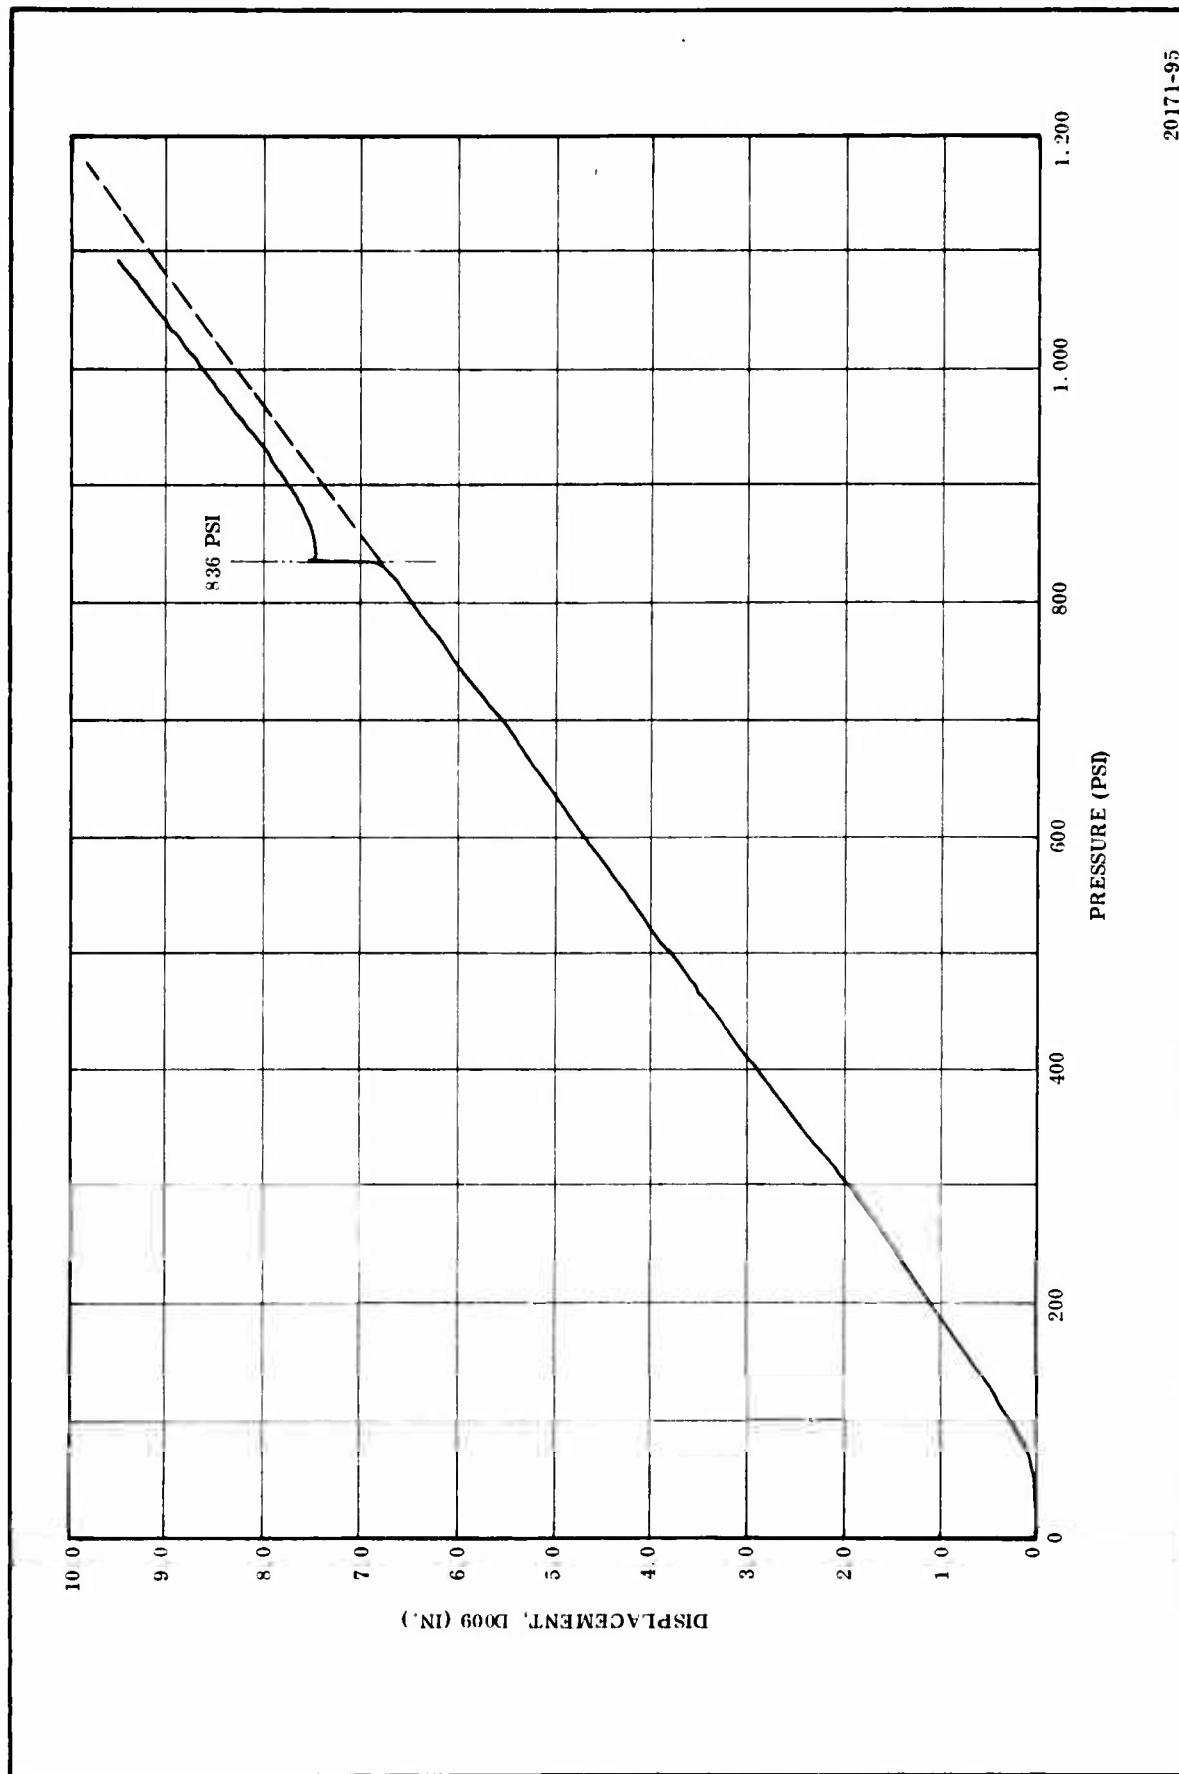
(U) Figure 54. Hoop Displacement, Forward Segment

(U) During hydroburst, cracking and popping was heard at 800 to 900 psig. Strain and extensometer data show that there was some increase in hoop and longitudinal strain in the forward segment at 800 to 900 psig. Figure 54 shows an increase of
